LIMITED INDOOR AIR QUALITY
INVESTIGATION AT

LEXINGTON POLICE HEADQUARTERS

150 East Main Street
Lexington, KY

Report Date: September 14, 2023
ASTI Project # PC542

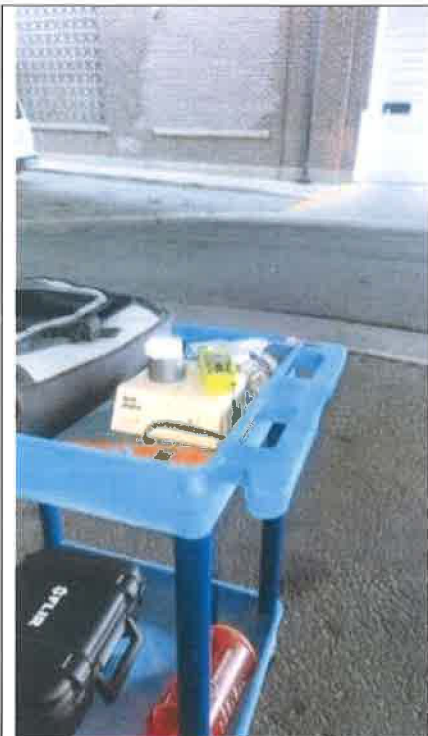
Outside air sample location

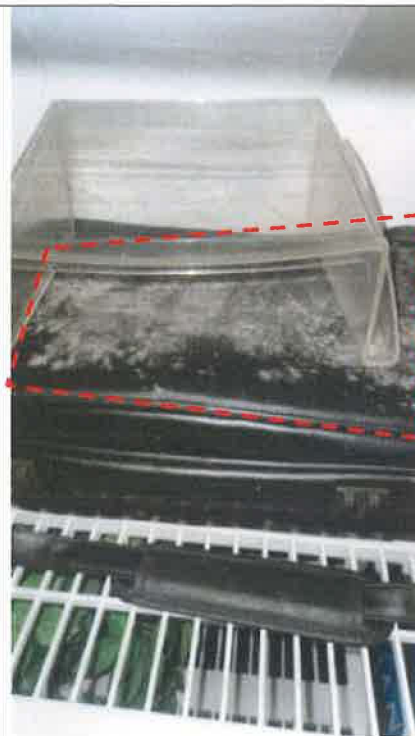
Moldy leather carrier in storage room

- B. Repair the roof and roof drain leaks as soon as possible.
- C. Following EPA guidance for the safety of occupants and maintenance staff, clean HVAC supply vents throughout the 4th floor. Clean or dispose of moldy items in the storage room.

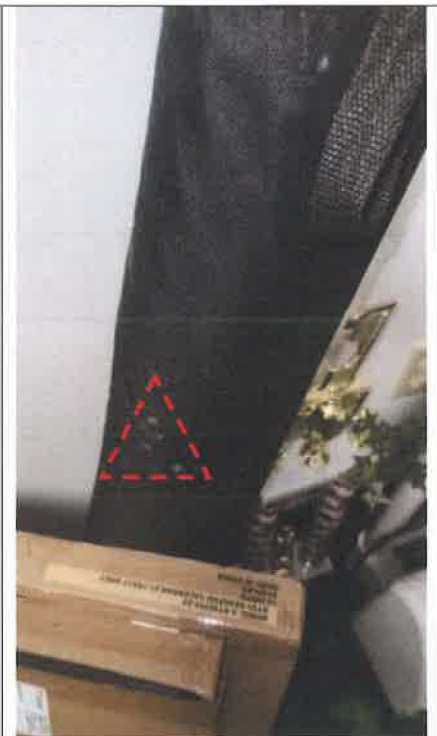
Moldy equipment case in storage room

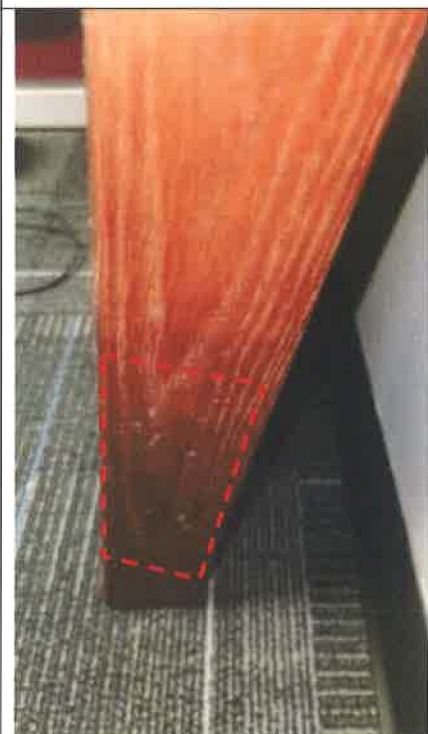
Moldy wood casing in storage room

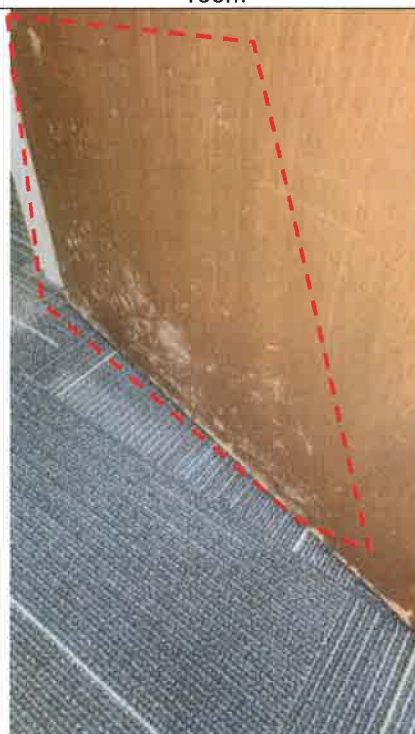
Moldy door in storage room

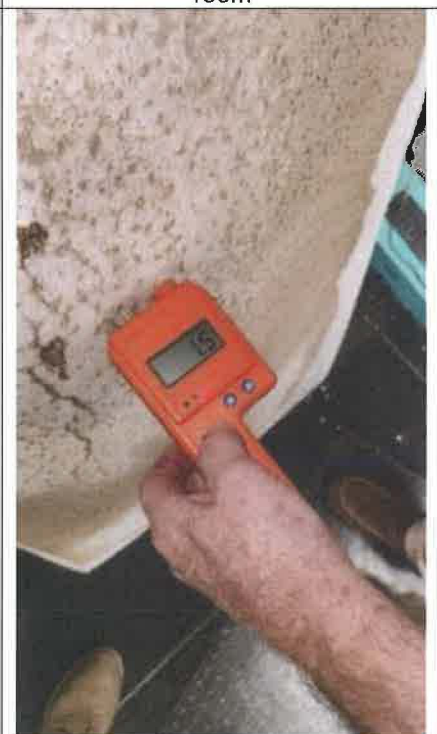
Water damaged ceiling in Room 403 was wet

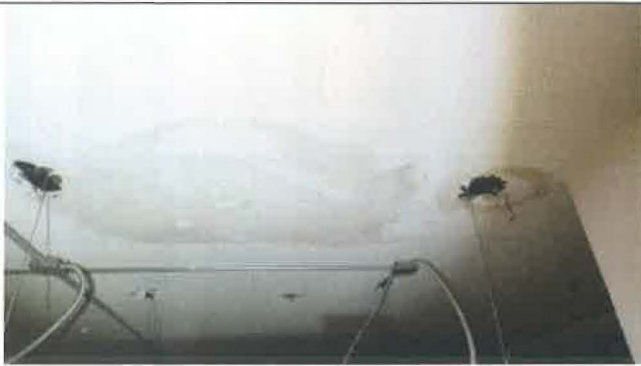
Water damage noted to drywall ceiling in multiple locations

- D. Replace water damaged drop ceiling tiles throughout the 4th floor.
- E. Address water damaged drywall ceiling above drop ceiling using a licensed asbestos abatement contractor. Clearance air samples for asbestos should be collected following abatement to document the area air quality is within EPA clearance criteria (<0.01 fibers per cubic centimeter).

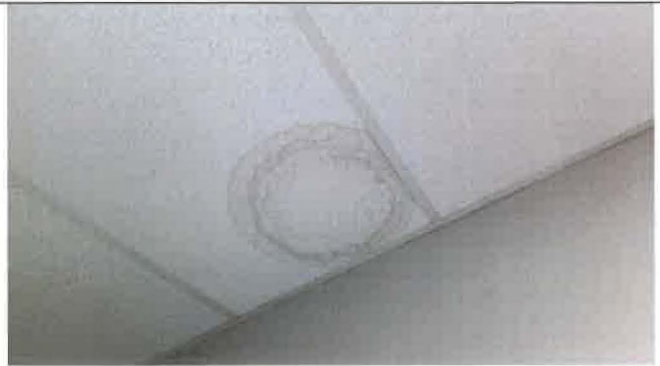
Water damage was noted to drop ceiling tile in multiple locations

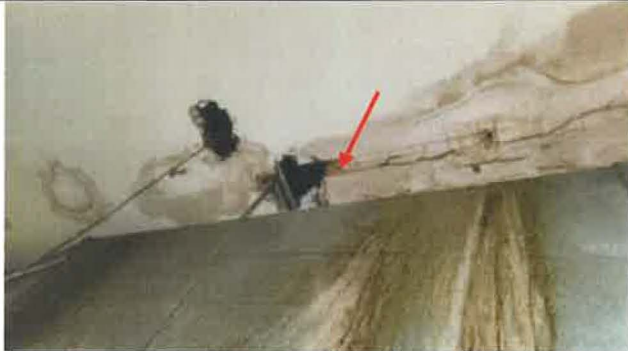
Summary of Sampling Results		
Sample ID	Description of Suspect ACM	Asbestos Content
A-1	Water damaged ceiling sheetrock	No asbestos detected
A-2	Water damaged ceiling sheetrock	No asbestos detected
A-3	Water damaged drywall compound	2% Chrysotile
A-4	Drywall compound – Lab Instructed to Stop at 1 st Positive – Not Analyzed

Drywall compound was found to be asbestos-containing material. Care should be taken to avoid disturbing this material without proper training.

Sample location for asbestos drywall compound (A-3 & 4)

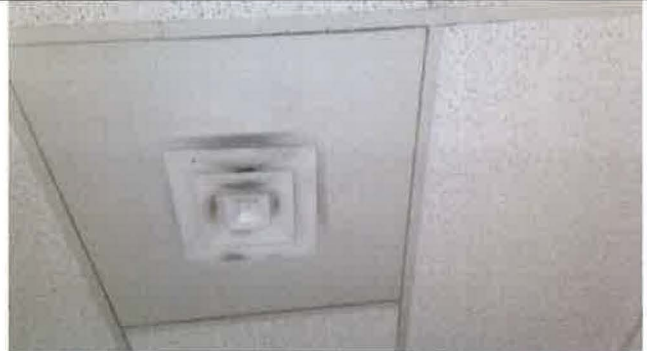
Dirty HVAC supply diffuser in Room 403

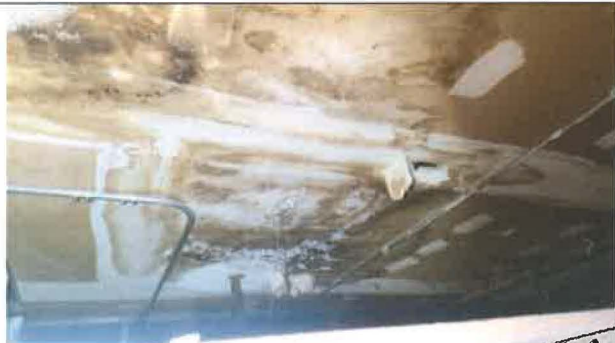
Water damage noted to drywall ceiling in Room 418

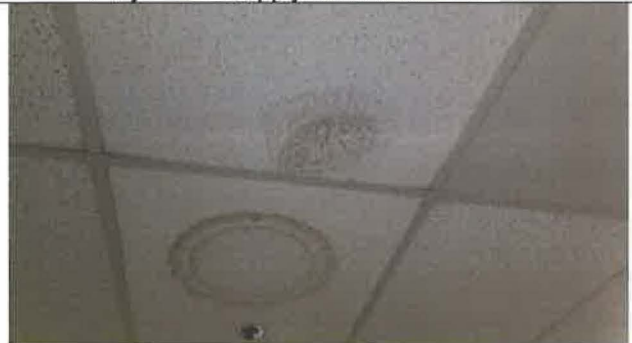
Water damage was noted to drop ceiling tile in multiple locations

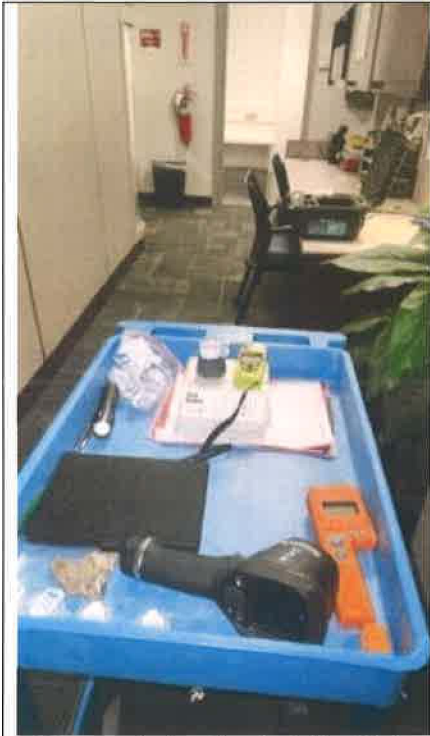
Air sample location in left cubicle hallway

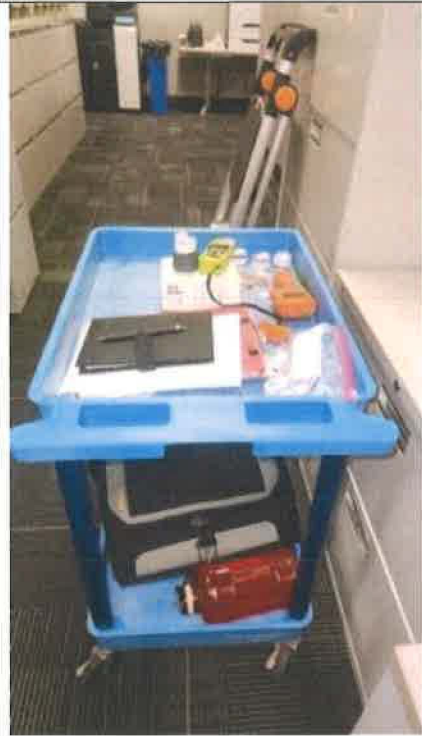
Air sample location in center cubicle hallway
